To: Martin Yale Technical Support

From: Martin Yale Engineering

Date: 5-November-2013

Subject: 2051 Folder, Instructions for replacement of original style home flag sensor with WRA2051144 retro-kit ('new' style home flag sensor)

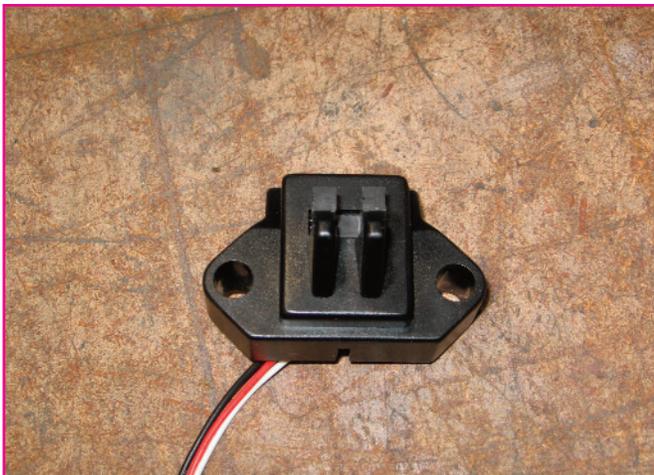
Original style 2051/2045 home flag assembly---Note 2 piece arrangement of sensor/housing.

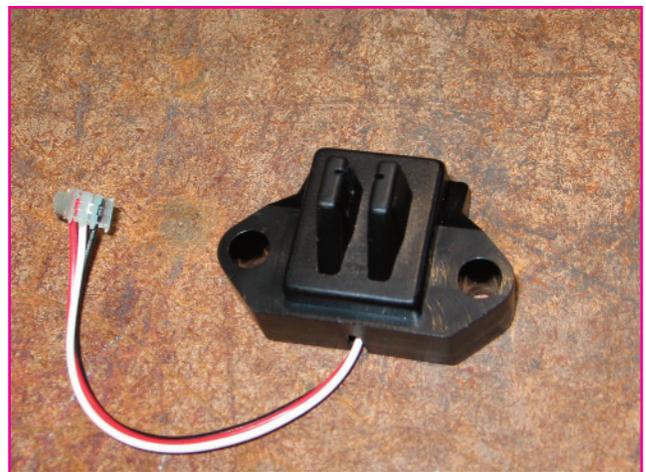
New style (WRA2051144) replacement home flag assembly---Note 1 piece construction.

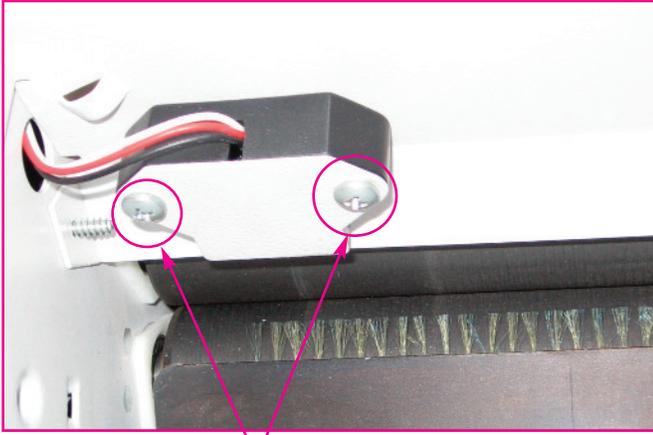
1st Fold Table Home Flag Sensor mounting screws

Sensor replacement: *WARNING: Unplug the Folder before performing any service on it.* Removal and replacement of the home flag sensors is largely self-evident by inspection. Replacement of both involves removing (2) philips mounting screws and unhooking its electrical connection. Removal of the 2nd fold table home sensor requires removal of the access panel located under the 2nd fold table. Removal of the 1st fold table home flag sensor may require removal of the folder's front cover in order to access its electrical connector.

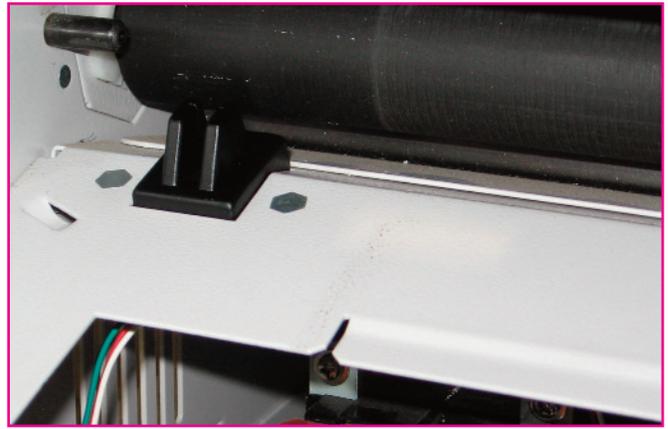
2nd Fold Table Home Flag Sensor-Mounting screws are underneath

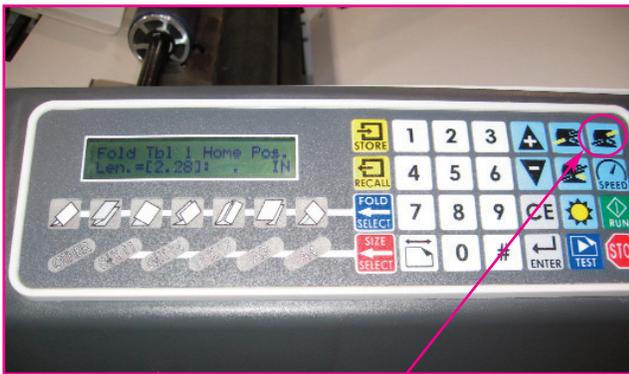
1st Fold Table offsets screen in diagnostic #7

- A. Power up the folder in diagnostic mode by holding down the 'STOP' button while turning the unit on. It is necessary to hold the STOP button down continuously until the diagnostic screen appears on the folder display. Then press '7' to access the offset limit settings.
- B. Once in the offset limit setting diagnostic menu, press the fold table button on the display that corresponds with the fold table system the technician is working with. Press the button for the first fold table if you replaced the home flag sensor for fold table #1 and press the button for the second fold table if you are working with that system instead.

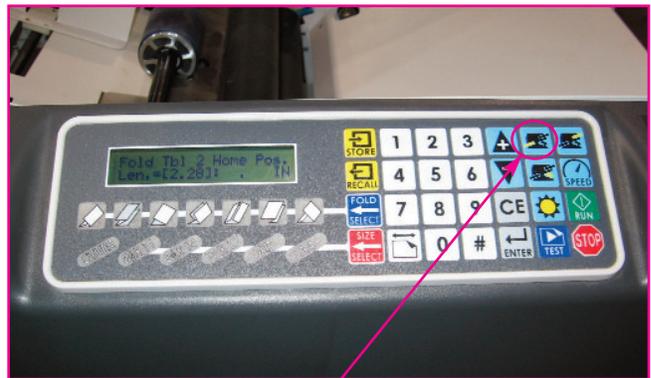
2nd Fold Table offsets screen in diagnostic #7

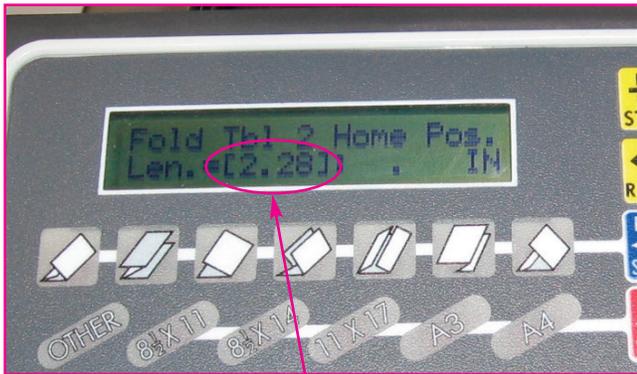
Offset value screen-Record number in brackets

C. When the fold table button is pressed a screen appears that reads: Fold Tbl X Home Pos. Len.=[X.XX]: . IN. Record the bracketed value on the display for 'X.XX'. It should be a number from approximately 2.27 to 2.30. Once you record that number, add .05 to it and enter that number on the display by using the keypad. For example, if the number given on the display is '2.28', add .05 to that to get 2.33. Then type the '2.33' value on the display. Once the new value is on the display press 'Enter'. If you replaced the first fold table home flag, you have finished with the software set-up and can move onto step 'E' below. If you replaced the home flag sensor for fold table #2, perform step 'D' below.

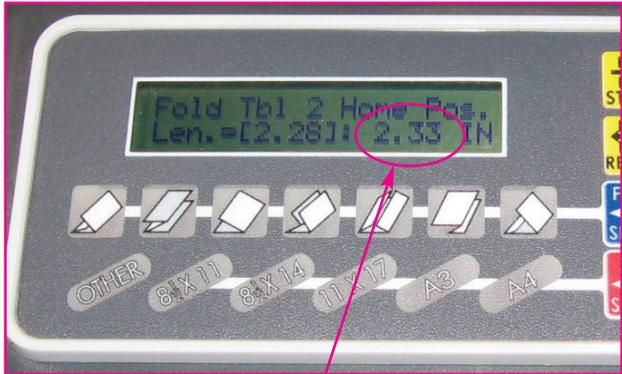
New value entered on display via keypad

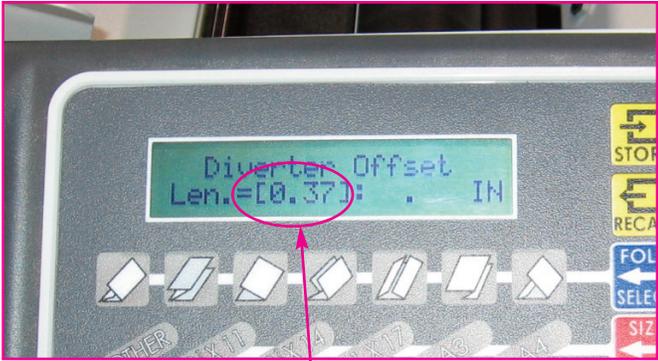
Diverter Offset Screen-Only applicable on Fold Table #2 settings

D. After pressing Enter in 'E' above, for fold table #2 only, a screen that displays: Diverter Offset, Len.=[.XX]: . IN appears. Record the bracketed value on the display for '.XX'. Much like in step 'C' above, add .05 to the number on the display and enter it on the display by using the keypad. For example, if the number given on the display is '.37', add .05 to that to get .42. Then type the '.42' value on the display. Once the new value is on the display, press 'Enter'. You have now completed the software adjustment for fold table #2.

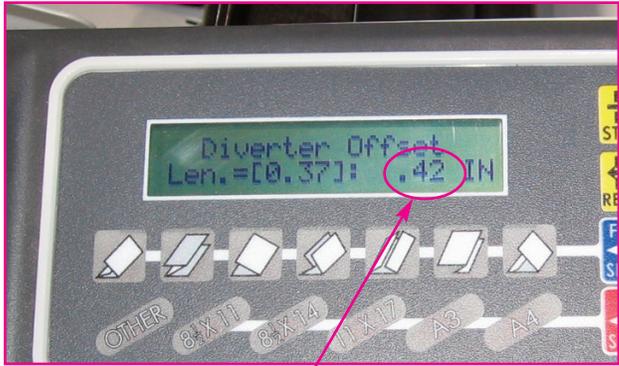
Diverter Offset Screen-New value typed in
